24TH
WFHSS
CONGRESS
BRUSSELS
18-21 OCTOBER
2023

Findings of an Internal Auditing Study of Insulation Testing Practices to Improve Healthcare Facility Testing Practices and Patient Outcomes

Cheron Rojo, BS, FCS, CHL, CIS, CER, CFER, CRCST

Senior Clinical Education Specialist,
Healthmark Industries

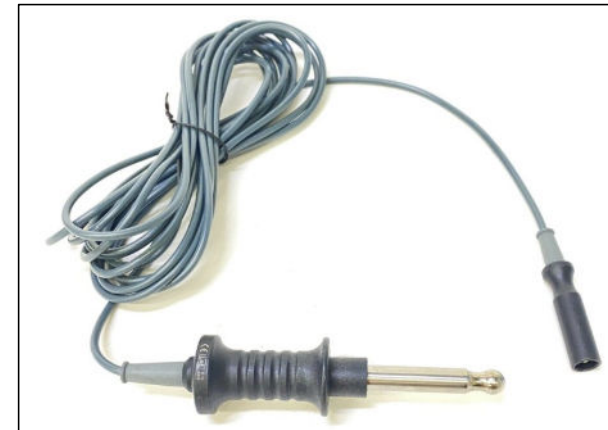
- **07-26-2021:** an insulated laparoscopic handle was found to have an insulation integrity failure and, “... it was reported that product arced resulting in blisters to the patient’s skin.”
- **08-10-2021:** an insulated laparoscopic 34CM Cautery Probe was identified with damage to the insulation coating and, “the instrument melted and arced from the side, burning an unintended portion of the liver.”
- **03-15-2022:** a monopolar-HF cable “... reportedly exploded during [the] procedure and burnt towards the end where the HF cord connects to the generator unit, and a minor deformation/kink was noted on the cable.”

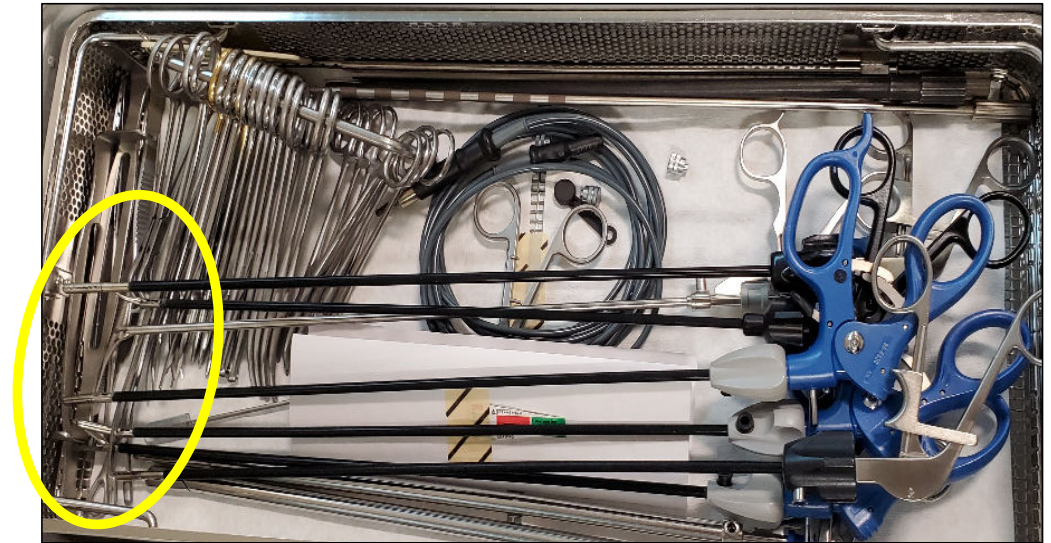
- Deficient containers/trays housing insulated laparoscopic instrumentation or correct container/tray but with the overflow of insulated instruments damaged by mixing with metal instrumentation.
- Inappropriate storage for backup insulated instruments (e.g., bins too small, excess amount of instrumentation, and tight spaces).

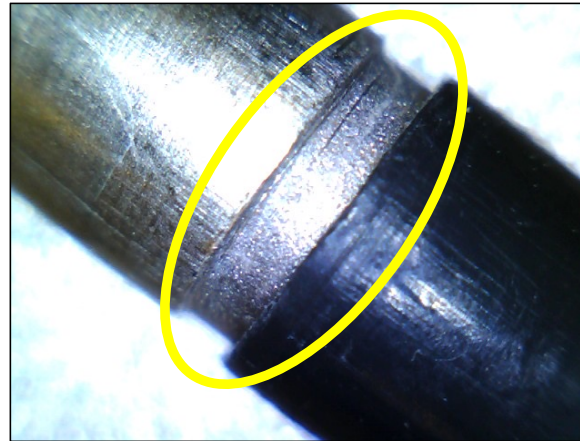
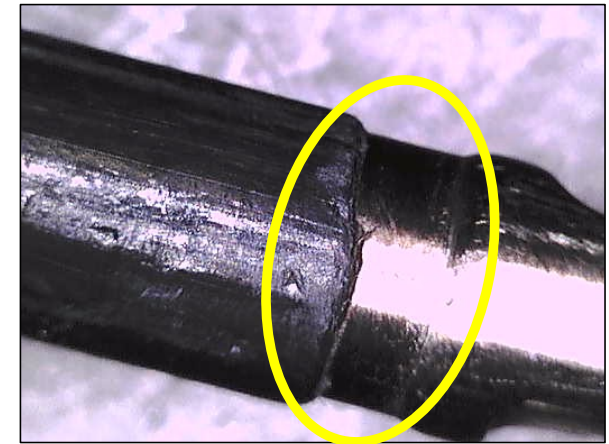
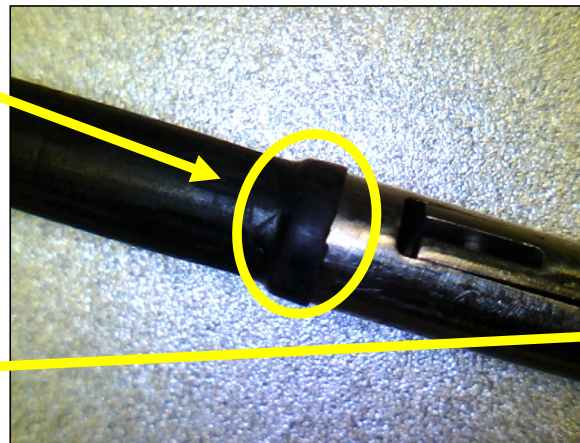
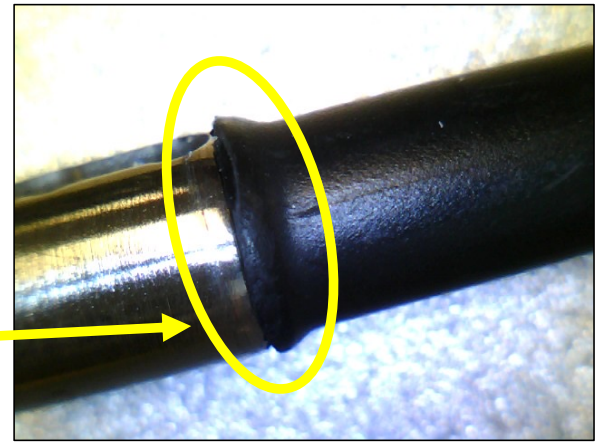
- Pull back (new damage) at the distal end of laparoscopic insulated instrumentation with no fraying for non-take-apart
- Pull back (old damage) at the distal end for laparoscopic instrumentation that has frayed insulation for non-take-apart
- Insulation layover '**Hangnail Effect**', where the insulation is laid over the distal working mechanism instead of being flush against it.
- Over time, this can cause the insulation to separate and/or pieces of the insulation to fray and pull back like a hangnail

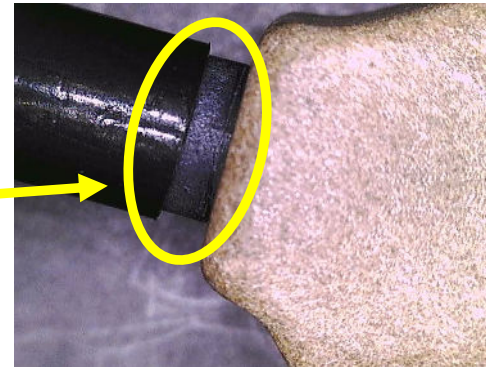
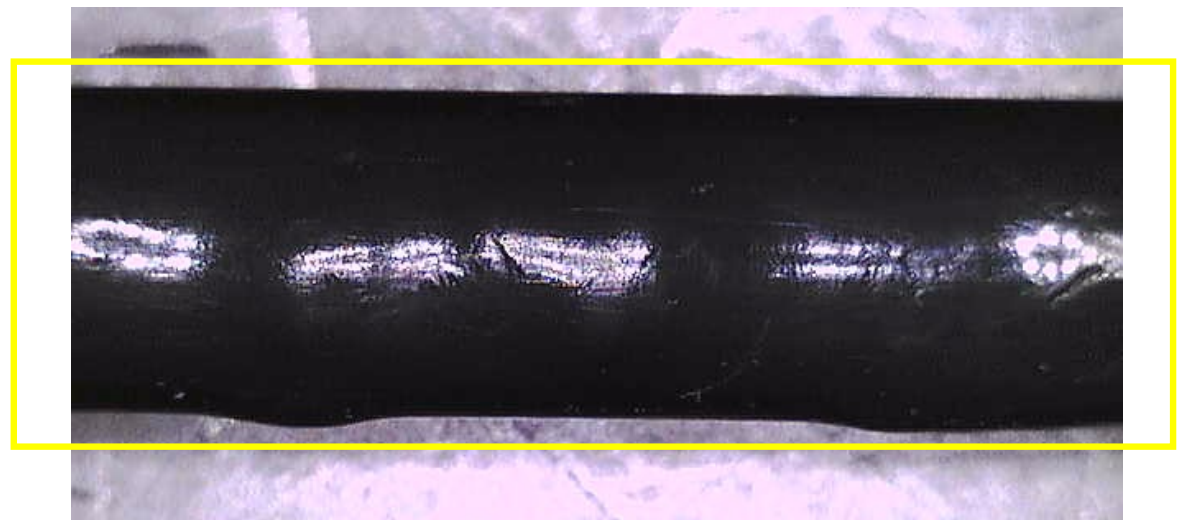
- Pull back at the proximal end for laparoscopic instrumentation that has separated from the base/handle for non-take-apart
- Newly insulated laparoscopic instrumentation with a glossy look and bumps along the shaft
- This is an insufficient repair where the inner insert was not completely cleaned/removed of old insulation, then insulated over the existing pieces.

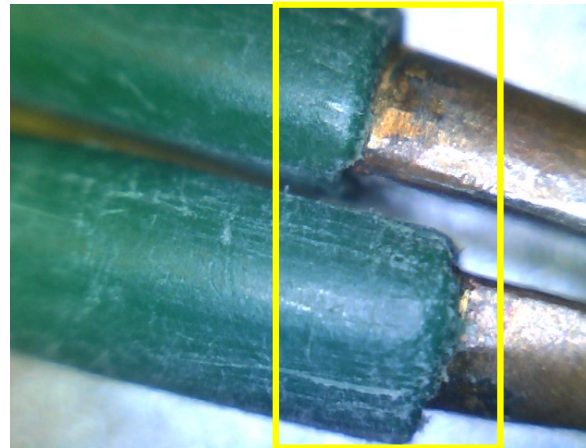
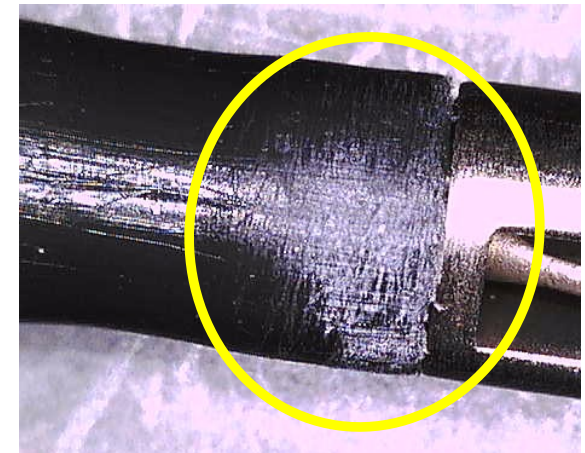
- Worn and weathered (old damage) nicks, scratches, and gouges on insulated instrumentation
- Insulation (old damage) that is gray, white, dull in color, and/or fuzzy for all insulated instrumentation

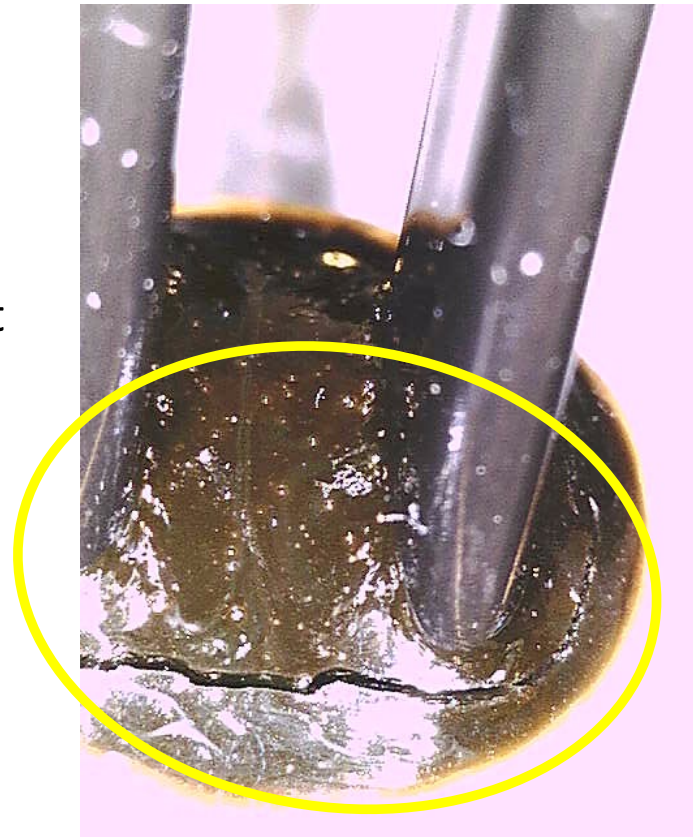
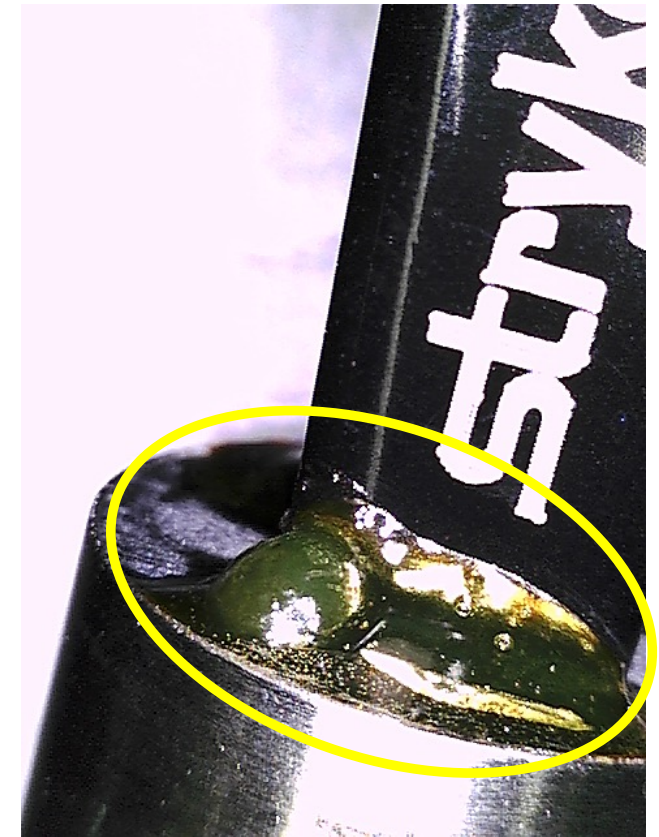
- Separation or excessive amount of epoxy resin that lifts from the base at the proximal end of an insulated bipolar forceps where the base connects to the tins of the forceps
