24TH
WFHSS
CONGRESS
BRUSSELS
18-21 OCTOBER
2023

Findings of an Internal Auditing Study of Insulation Testing Practices to Improve Healthcare Facility Testing Practices and Patient Outcomes

Cheron Rojo, BS, FCS, CHL, CIS, CER, CFER, CRCST

Senior Clinical Education Specialist,
Healthmark Industries

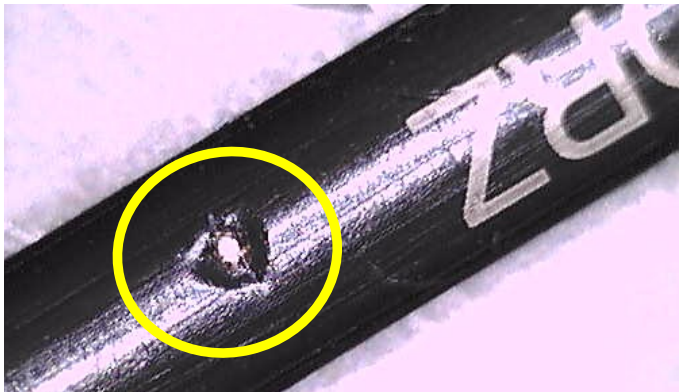
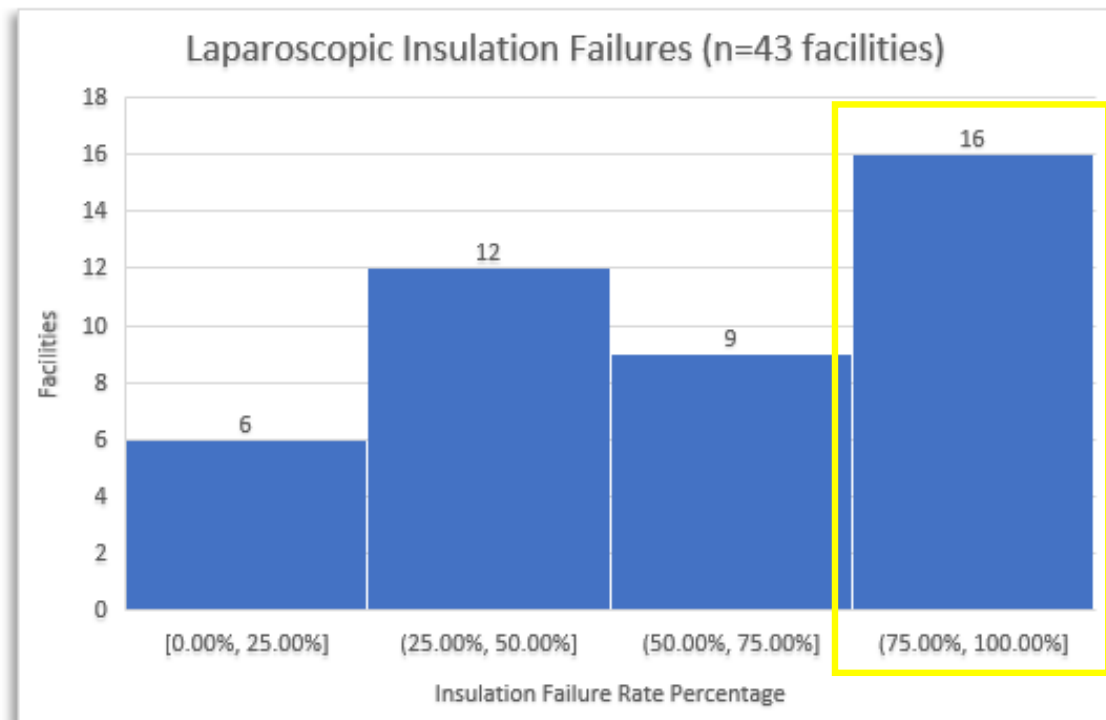
- Of the total 416 instruments tested, 223 showed failures on insulation testing or inspection.
- With 16 facilities showing a failure rate of 75%–100% of all devices tested.

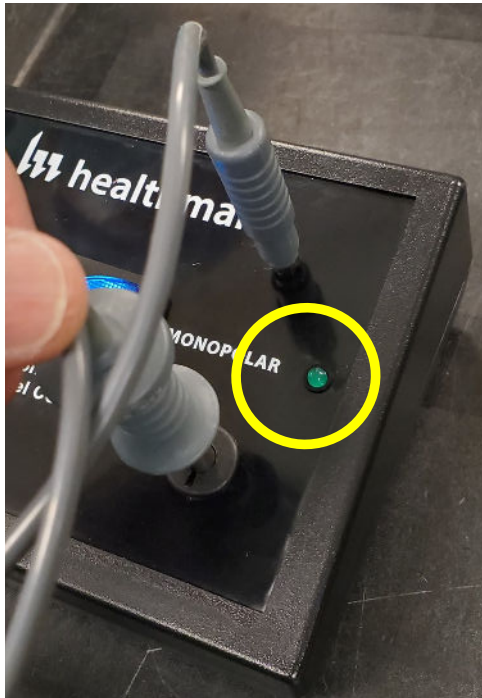
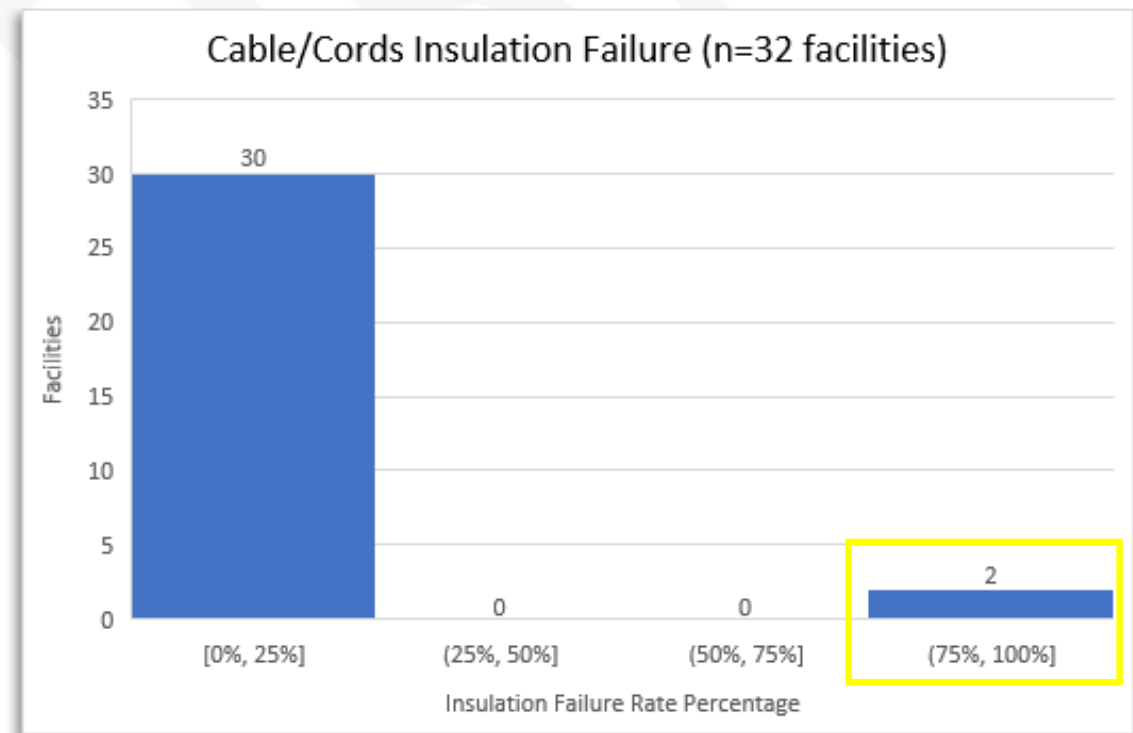
- On average, insulated cables demonstrated a 6% failure rate for continuity across 32 facilities.

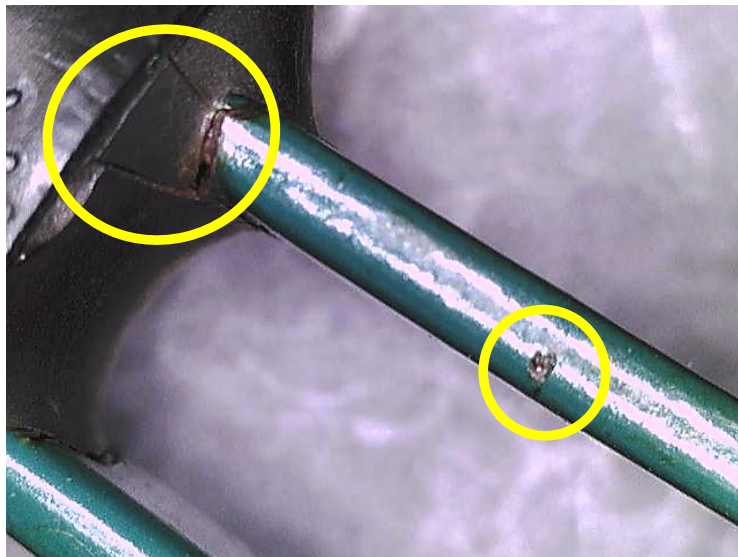
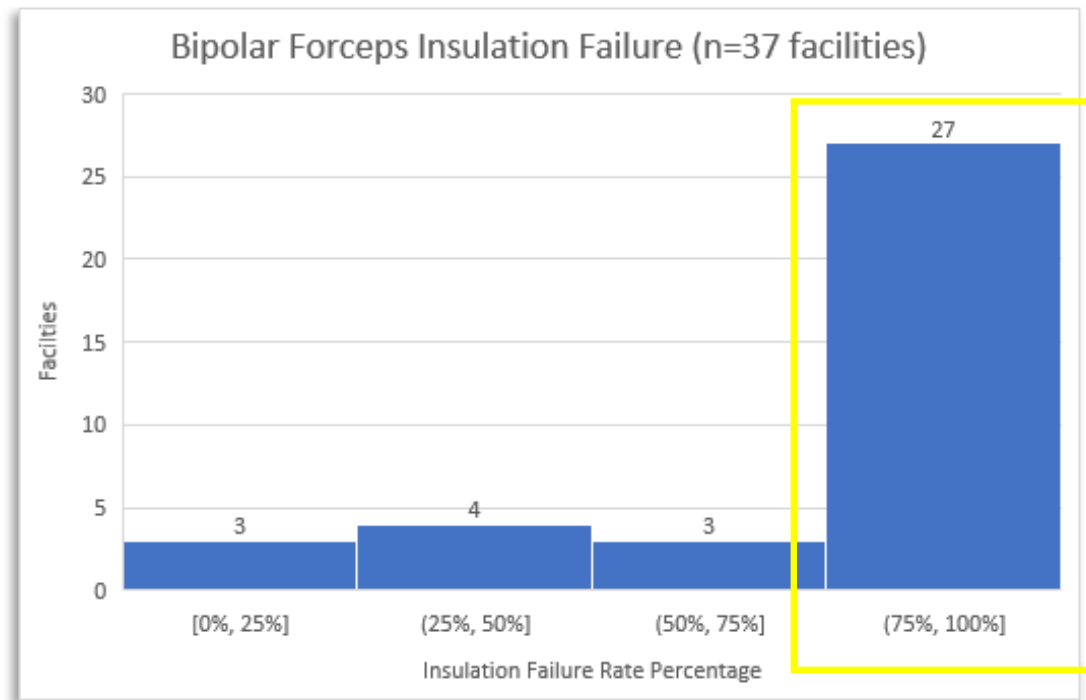
- Bipolar forceps had the highest failure rate with 27 facilities having a 75%–100% failure rate for those devices

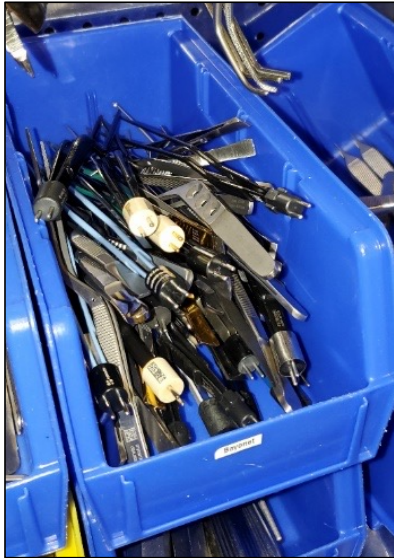
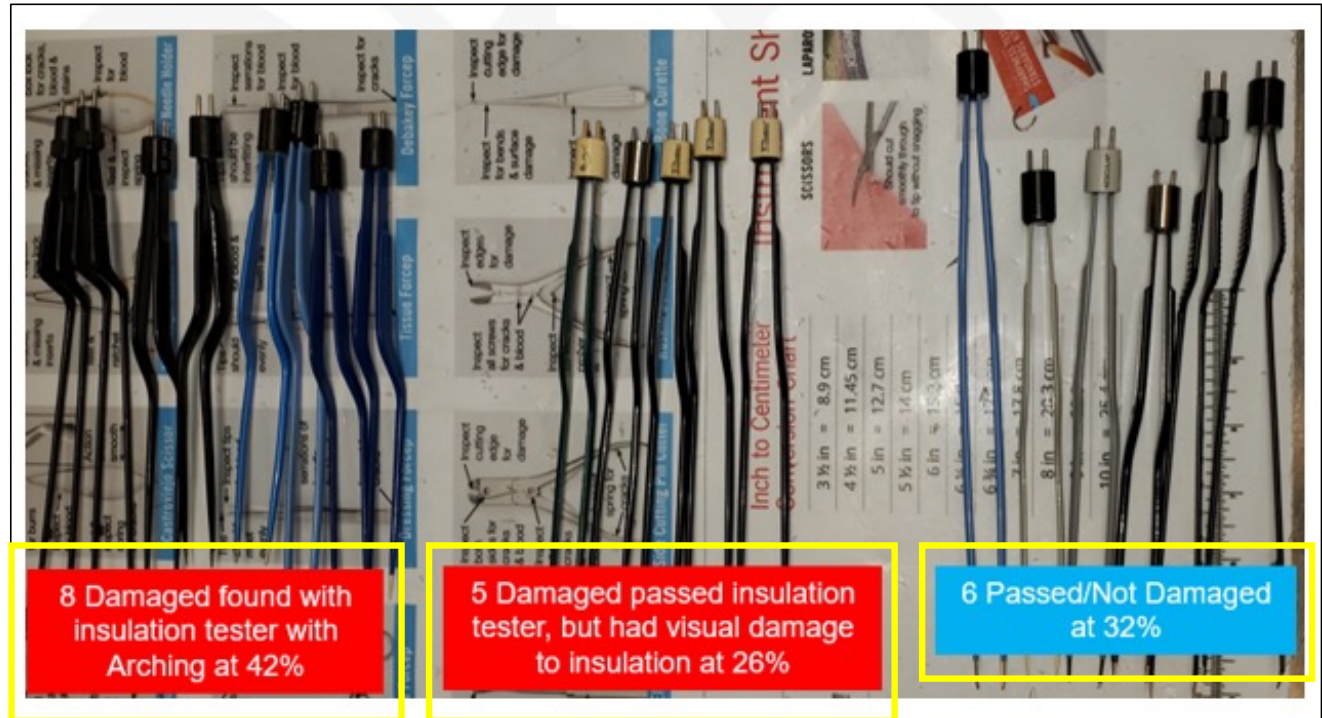
- In one of the 27 facilities, 19 insulated bipolar forceps were tested from ready-to-use backup inventory.
- 13 of the 19 were identified as having insulation failures

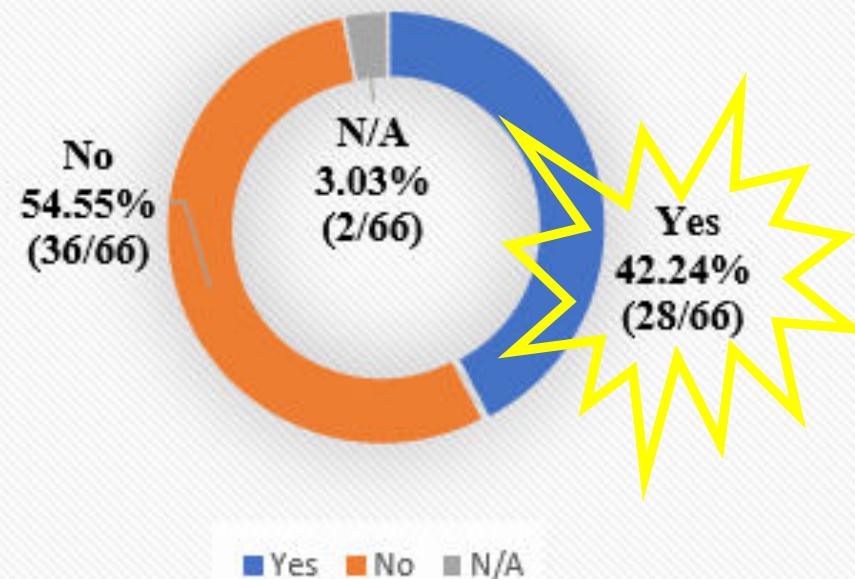
Operating Room Nurses That Experienced a Malfunction During Surgical Procedure

- For the qualitative aim of the study, operating room (OR) nurses were asked about their personal experience with insulation malfunctions during a surgical procedure during their career.
- A total of 66 responses were received by respondents: Yes: 42.24% (28/66), No: 54.55% (36/66), N/A: 3.03% (2/66).

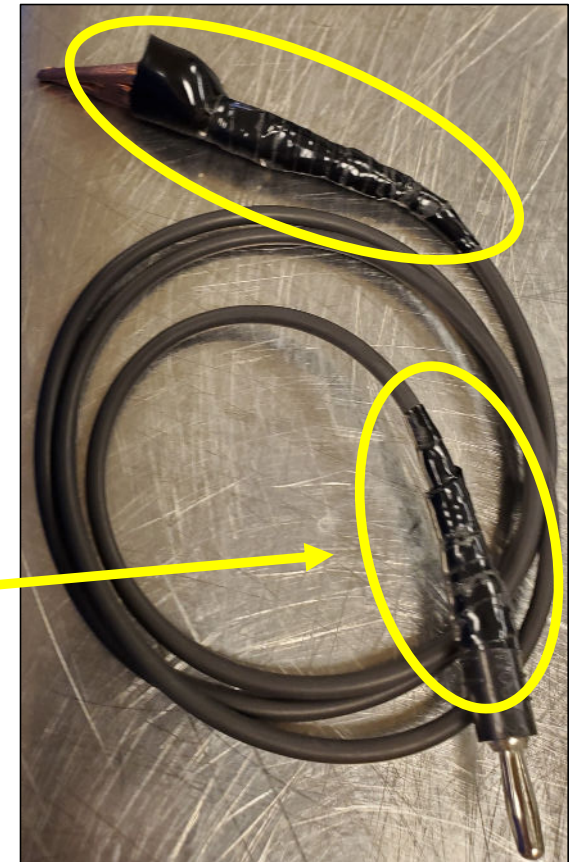
- Inadequate magnification to clearly identify the damage (e.g., only standard lighted magnification and not enhanced magnification microscopes to visualize at a higher magnification).
- Insufficient insulation testers lacking the sensitivity and the ability to test a wide range of insulated instrumentation (e.g., bipolar forceps). Damaged and missing accessories and insulation unit.
- Lack of education for technicians in identifying damage and operation of the insulation testers.

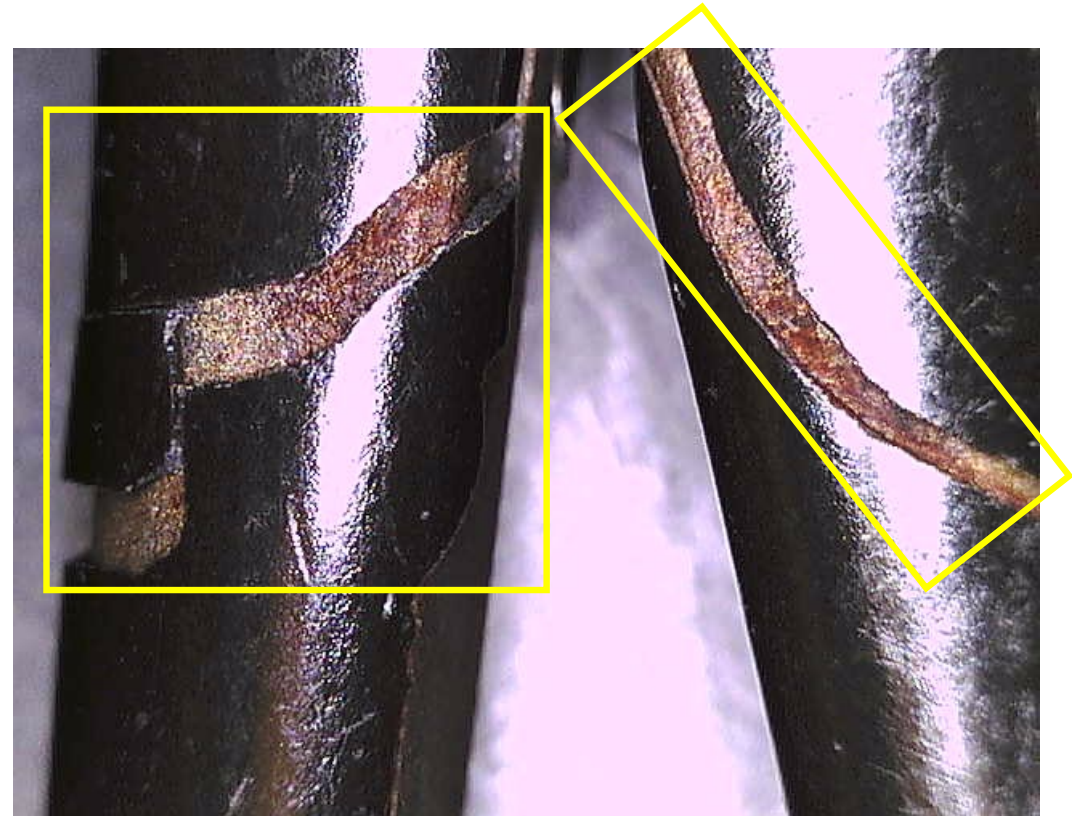
- Insufficient repair service for insulated instrumentation (e.g., poor repairs, not in the contract, not frequent enough).
